INDOOR AIR QUALITY ASSESSMENT

**Department of Mental Health
Lindemann Building, Chelsea Conference Room Suite
25 Staniford Street
Boston, MA**

Prepared by:
Massachusetts Department of Public Health
Bureau of Environmental Health
Indoor Air Quality Program
October 2016

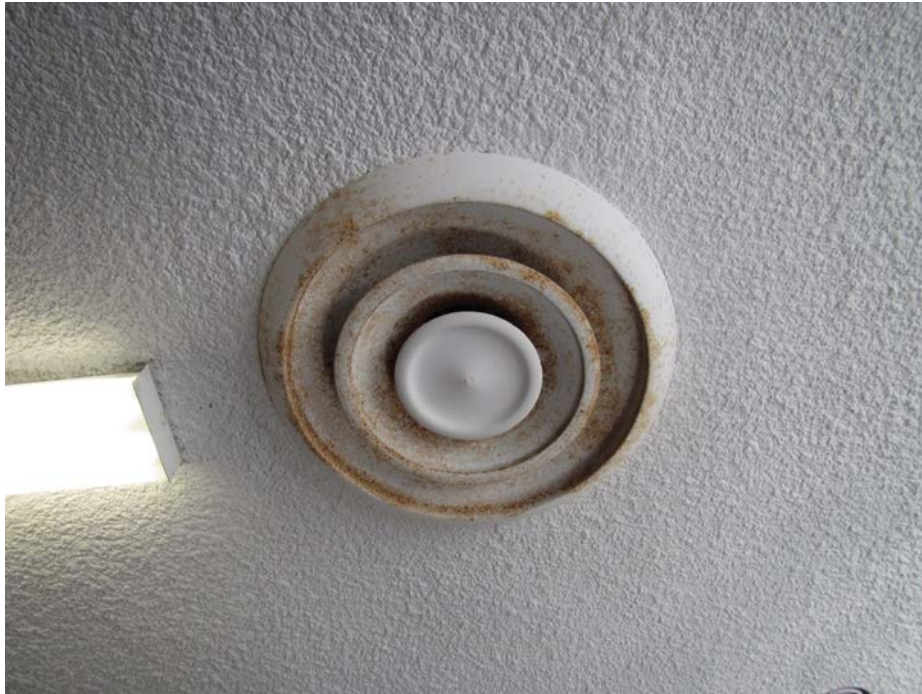
Picture 1

Fresh air is provided by air handling units (AHUs). Air from the AHUs is filtered, heated/cooled, and delivered to rooms via ducted supply vents (Pictures 1 and 2). Air is returned/exhausted through vents in the ceiling (Picture 3). Additional heating is provided by radiators along outside edges of the building (Picture 4).

No water-damaged porous materials were observed in the office suite. A supply vent in the main office showed signs of rust (Picture 1) which indicates that water has condensed on the metal surface of the vent during humid conditions. If this is a frequent occurrence, the temperature of the supply air may need to be adjusted.

Supply vent, note rust

7. If condensation regularly occurs on supply vents during humid weather, contact the building maintenance department regarding the temperature of the supply air.

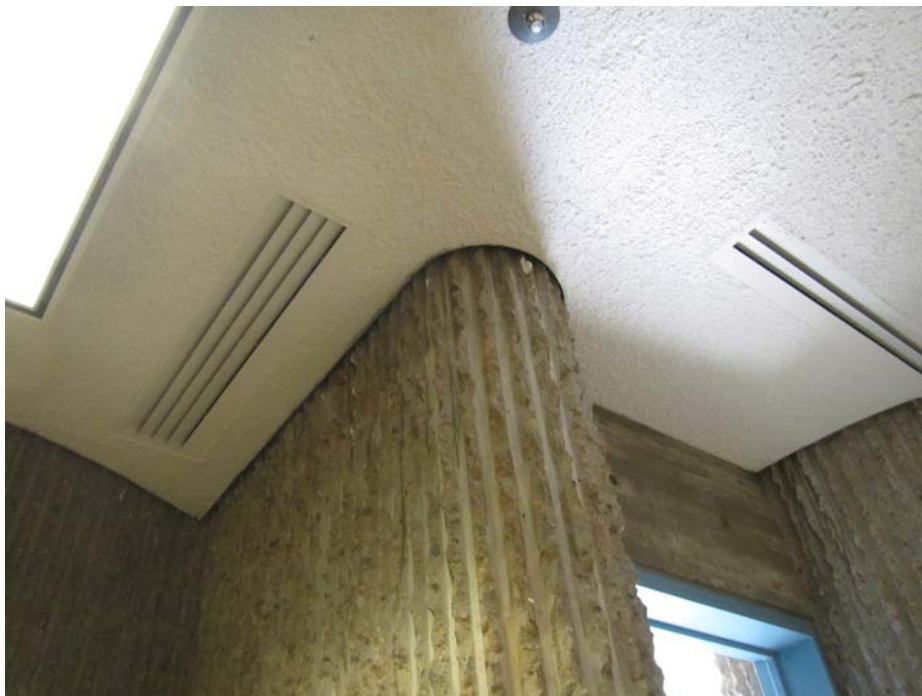
Picture 2

Supply vents

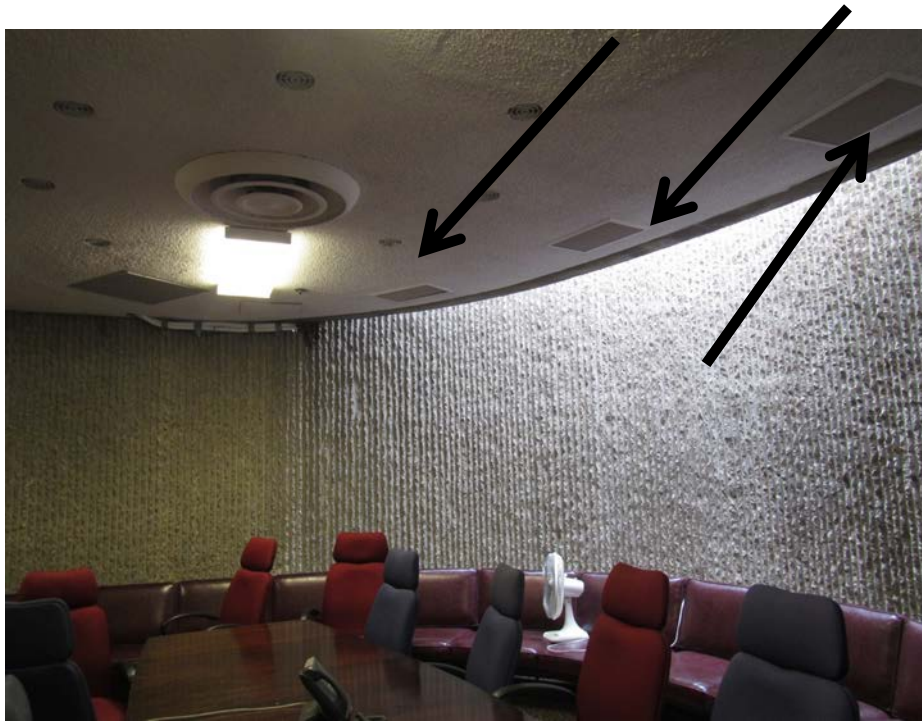
Picture 3

Exhaust vents (arrows)

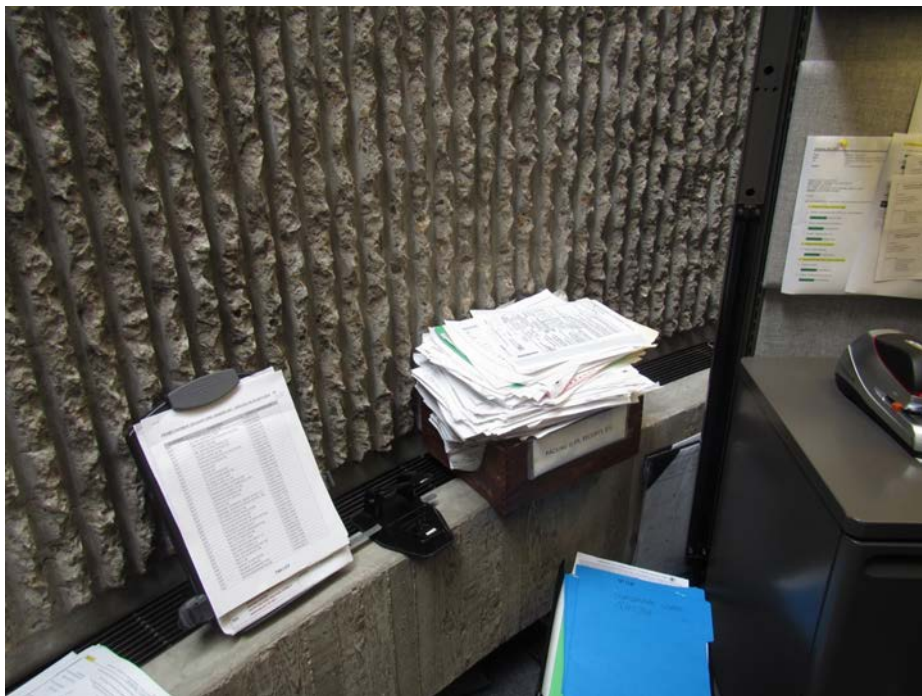
Picture 4

Items, including books and papers, were found on top of radiator vents (Picture 4). Radiator vents in the CCR were also dusty. When the vents are in operation, the heat creates a stack effect that distributes heated air to the rest of the room, and can thereby distribute dust and odors from materials on top of the vents. All vents should be kept free of items and cleaned periodically.

Items on radiator

4. Change filters on AHUs on a regular schedule at least twice a year.
5. Remove items from the top of radiators.
6. Clean flat surfaces, vents and radiators periodically to remove dust that may become aerosolized.

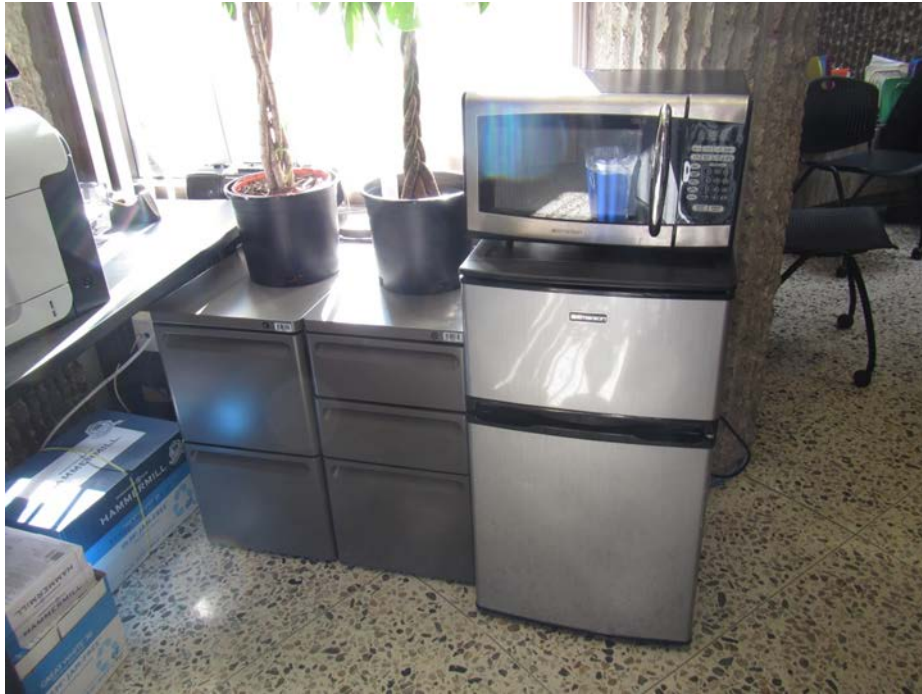
Picture 5

A few plants were observed in the office (Picture 5). Plants should be kept in good condition, not overwatered and not placed on porous materials or in the airstream of HVAC equipment.

Sunlight leading to solar heating was observed through the window in the main office area (Picture 5). This is also near the thermostat for the office. Shades/blinds should be used to reduce the impact of solar gain on the office temperature, especially if solar heating of the thermostat leads to excess cooling in the office.

Plants in the office, note strong sunlight through window

8. Ensure plants are well maintained, not overwatered and not placed on porous surfaces.
9. Reduce use of cleaning products, sanitizers and other products that contain VOCs.

10. Use shades to reduce solar heating and the impact on the thermostat in the office.
11. Clean carpeting in accordance with IICRC recommendations (IICRC, 2012).
